Rock slope stability – planar shear failure

This engineering manual describes a slope stability evaluation of an excavation situated next to the road number II/102 Strnady-Stechovice, which is located at the bottom of the Vltava river valley. The stability of the slope has been affected by crumbling stones, rock-layer slip down, underground water damps and unacceptable rock face stabilization since 1931, even though stabilization works are done frequently. The biggest slip failure happened in 1924, when 8,000 m³ of rock mass slipped down. In 2011 a 2-ton block of stone rolled down on the road. A selected cross-section will be evaluated in the following text.

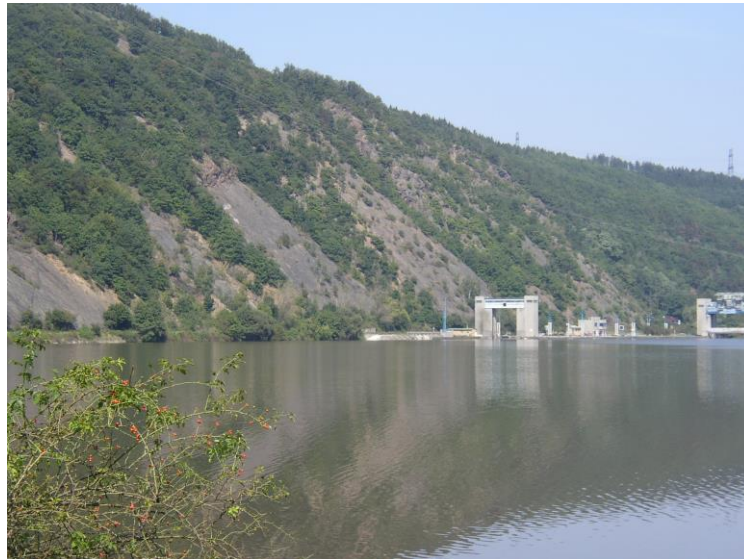
Picture of the most dangerous section – Vrane nad Vltavou part (photo S. Chamra)

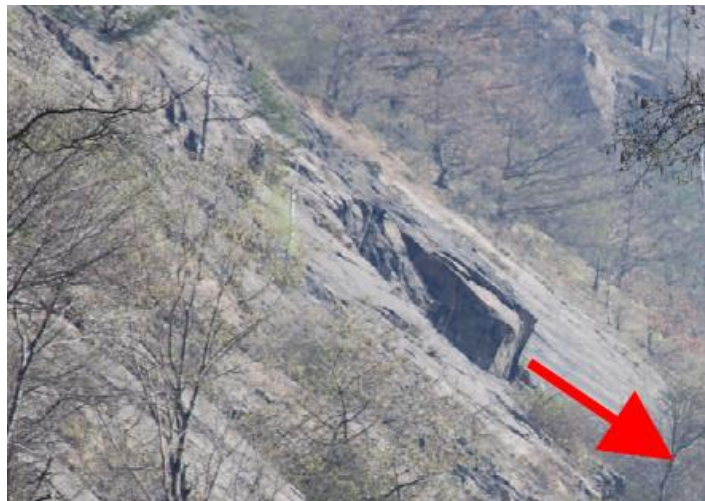
Rock-block with a translation movement presumption (photo Vaniček 2009)

An example of the slope stability task is related to the selected rock-slope in the section with the highest sudden rock-block landslide possibility. The evaluation is done in the long run, the accepted factor of safety must therefore be at least 1,5. In a situation, when the factor of safety is lower than 1,5 a stabilization design of the failure would be necessary.

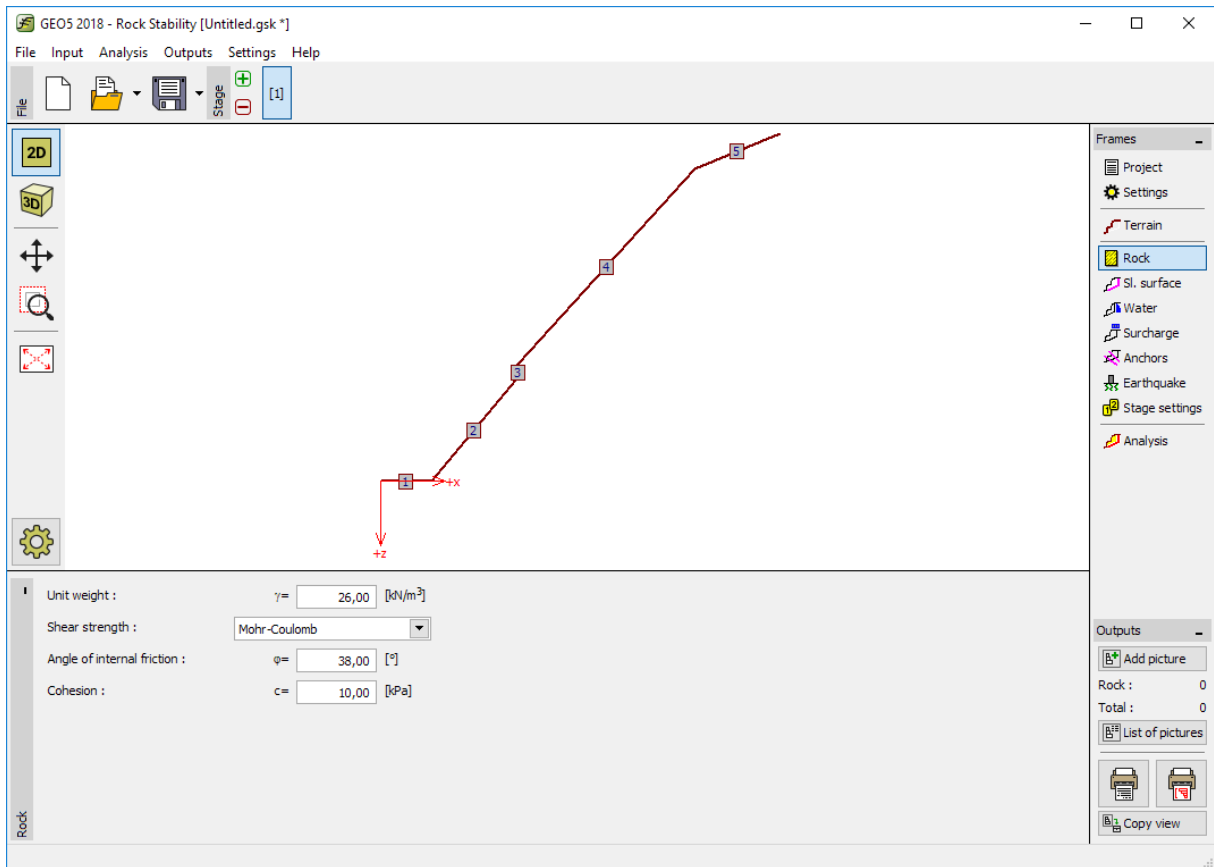
We set the rock-mass cross-section up (mechanical properties) in the "Rock" frame. Based on the geological investigation, which was conducted, the following unit weight and shear demerits (Coulomb

model) were recommended: unit weight $\gamma = 26 \text{ kN/m}^3$, residual shear strength on bedding planes – residual friction angle $\phi'_r = 38^\circ$, and residual cohesion $c'_r = 10 \text{ kPa}$

“Rock” frame

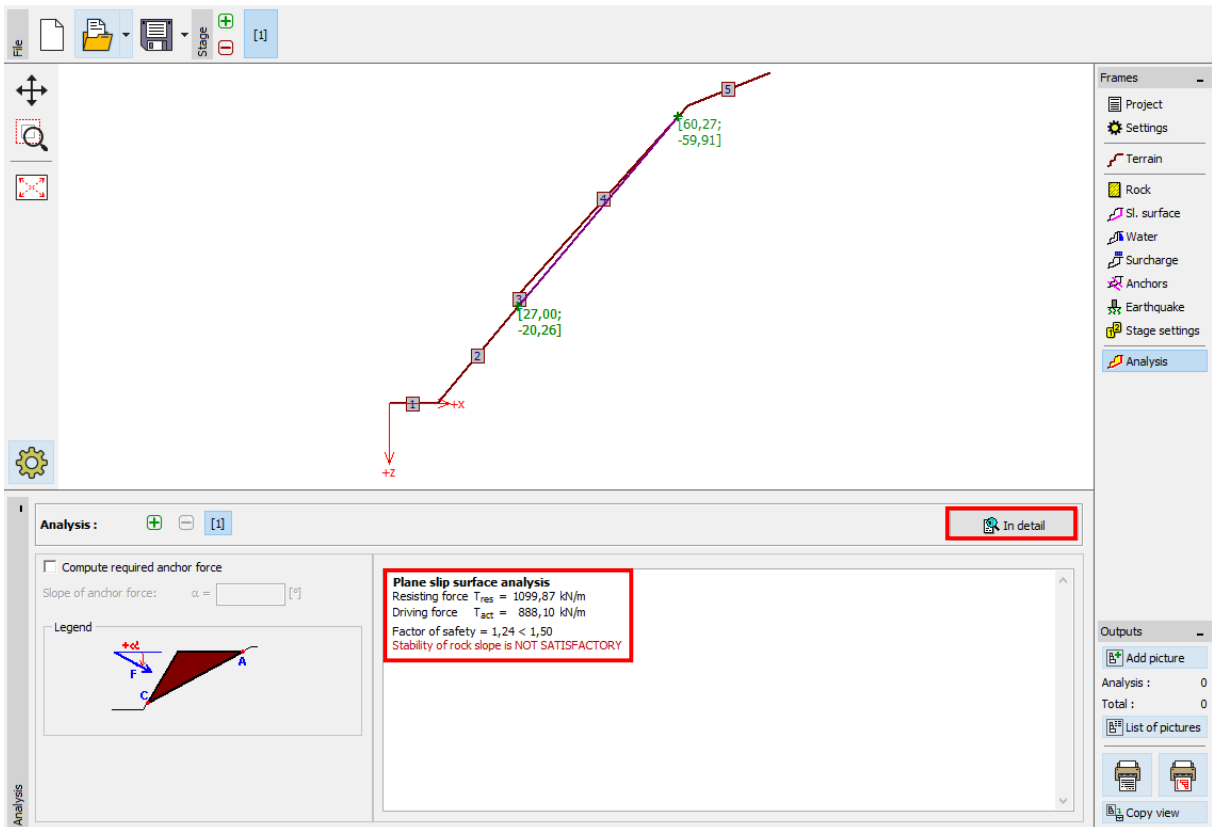
The task assessment will run after clicking the “Analysis” button. The basic results are visible in the frame “Analysis”. Our task slope stability result is $F = 1.24 \ll 1.5$. Detailed results are shown in the window “In detail” and/or in the document print view.

Frame “Analysis”

Analysis	
Partial results	
Slip surface length	= 51,77 m
Slip surface gradient	= 50,00 °
Gravity force	$W_z = 1159,33 \text{ kN/m}$
Normal force on slip surface N	= 745,20 kN/m
Shear stress on slip surface τ	= 21,25 kPa
Plane slip surface analysis	
Resisting force T_{res}	= 1099,87 kN/m
Driving force T_{act}	= 888,10 kN/m
Factor of safety	= 1,24 < 1,50
Stability of rock slope is NOT SATISFACTORY
